Chhimbu School Monitoring Report 10th September 2008

Submitted to
Himalayan Project Demark
By
Namgyal Jangbu Sherpa
Himalayan Project Nepal (HIPRON)

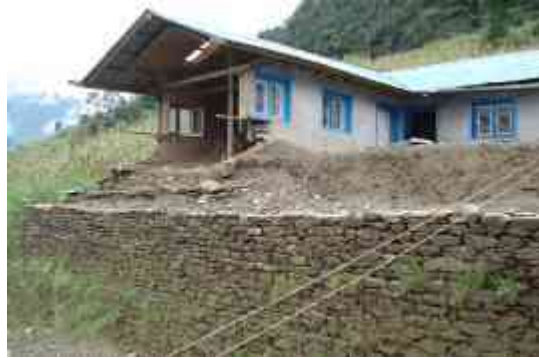
I met teaching staff, building contractor Dili and cement plastering contractor Gelu and discussed about the cause of collapse of office reconstruction site extensively.

During the discussion teacher blamed to Dilli for the collapse, Dili claimed that it was just coincidence. Headmaster Bimsen has proposed of breaching the contract with Dili as he failed to maintain the standard and quality of the reconstruction site but he rejected it as he already deeply involved in this project.

Then, we visited Sagar Bakanje School and observed newly constructed science lab building and found the work of Pasang Tamang, the major contractor, is highly expert and satisfactory. So, we decided to employ Pasang and his friends, who involved in science lab construction, for the Chhumbu school office rebuilding and wall construction. They also agreed to do the job as per the project description and Dili too agreed to employ Pasang Tamang and his friends. So, we entrusted Pasang for the quality of his work. Dili will act as a contractor- keeping the record of the things, supply stones, keeping the daily attendance of the Pasang and his friends and making payment for them. We also decided that payment of the workers will be done on the weekly basis óend of the week. Pasang and his friends have already started the re-construction site. We also agreed that existing building and wall will be demolished up to the main foundation and reconstruct from the beginning.

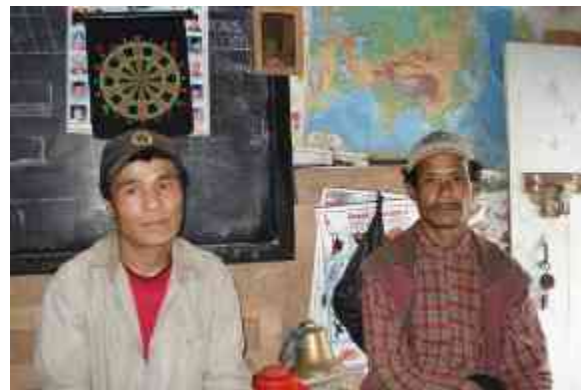
Cement plastering work of Gelbu Sherpa

We also monitored the cement work of Gelbu. He has done good job with outside plaster, paving stone slate around surface of the school building, Cement topping wall along the highway. But regarding the work of cement RCC on the office foundation he had used bad stone and too less cement. So, the RCC was not strong enough to resist against the crack. But this is not the main cause of office damage.

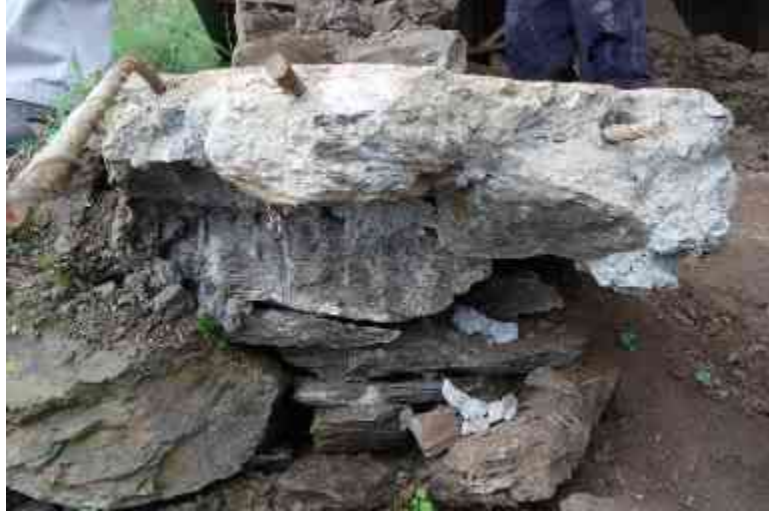
Cement Rcc made on the foundation for the stability of the office

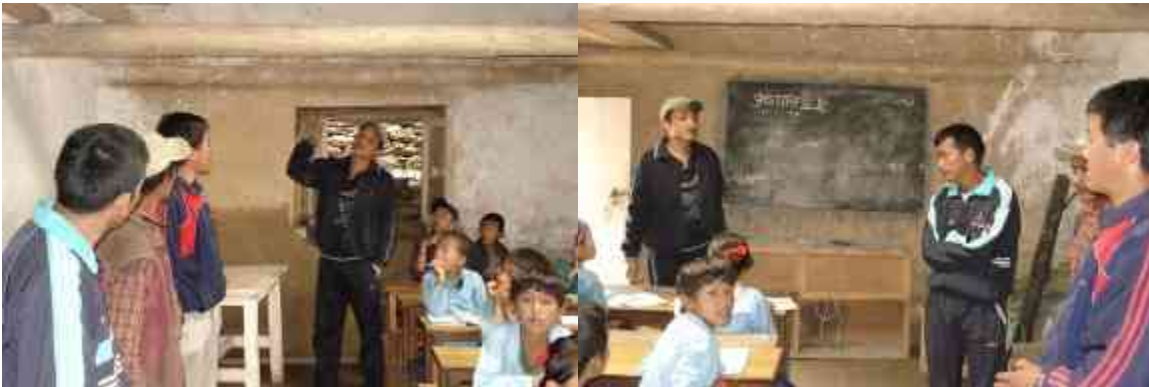
New classroom for the nursery students

New classroom for the nursery class, which can also be used for women's groups (sewing to make school uniforms etc) has recently finished. It looks good from outside but inside some minor things like re-plastering inside the room, fixing the proper ceiling and coloring inside the wall which were left to be completed. This is the work of 2 man a day though. Contractor Gelbu Sherpa and Dili Thami agreed to complete the remaining work within a few days. It is their responsibility to handover this room for the school management committee with good finishing.

Nursery class is being inspected by contractors and teaching staff. Bimsen is informing about the remaining work

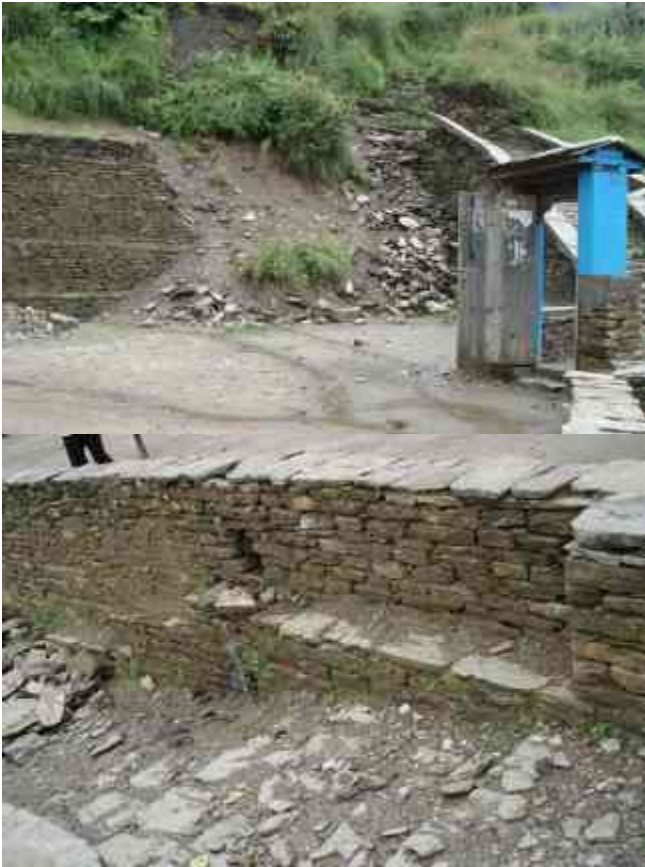
Supporting wall at the corner of the playground

Support wall for the Geluø land was collapsed. This wall was constructed last year and handed over to the school with the proper condition. But according to the agreement made by the school with Contractor it says that contractor should reconstruct the wall in case something is happened within one year. Contract is still valid. Gelbu Sherpa from Kinja and Dili Thami from Chhimbu were the contractor for this wall. They also respected the contract and wanted to rebuild it again. The main problem with this wall is that water is still springing form the foundation in the rainy season and it makes foundation loose and weaker, and finally resulted the wall to collapse. So, this water source needs to be managed and drainage system needs to be dug to send the water out to the area.

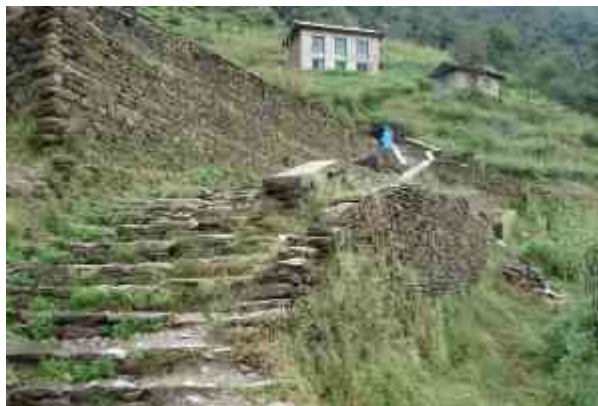
The wall of the lower part of highway

The wall of lower part of highway was constructed not according to the project description. Foundation is still strong enough but wall after the foundation is very loose inside and stones were not properly layered. Dili did the work very fast. Stone was put outside and inside was filled with mud. Stone was not arranged and tied each other properly. So, inside mud has pushed the wall down to demolish. This wall will also be demolished up to the main foundation and reconstruct it again. The same thing will happen with the office reconstruction site.

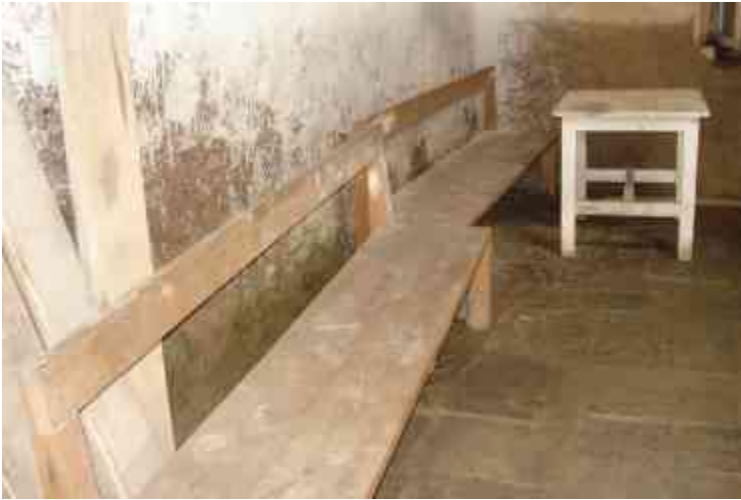
New furniture in

One cupboard, one table and a couple of benches have been made for the office room. They are kept in nursery class for a while. The quality of the table and benches are alright but cupboard doesn't look nicely fixed. The measurement of the table is: in length 3feet, breadth 2.6feet and height 2.6feet. Benches: length7.5feet and width 1.5feet.
