## Himalayan Project Nepal

### Monitoring Report 12 April to 14 April 2015

<b>Project</b>	: Chhiringkharka Primary School Reconstruction
<b>Location</b>	: BakanjeVDC -2, Solukhumbu, east Nepal
<b>Project Status</b>	: Fundament and Construction phase
<b>Purpose of monitoring</b>	: Check the materials supplied and being supplied : check the Fundament of the school buildings
<b>Donor</b>	: Padborg-Krusa Rotary Club, by Rtn. Bonnik Hansen Fund : The Human Practice Foundation

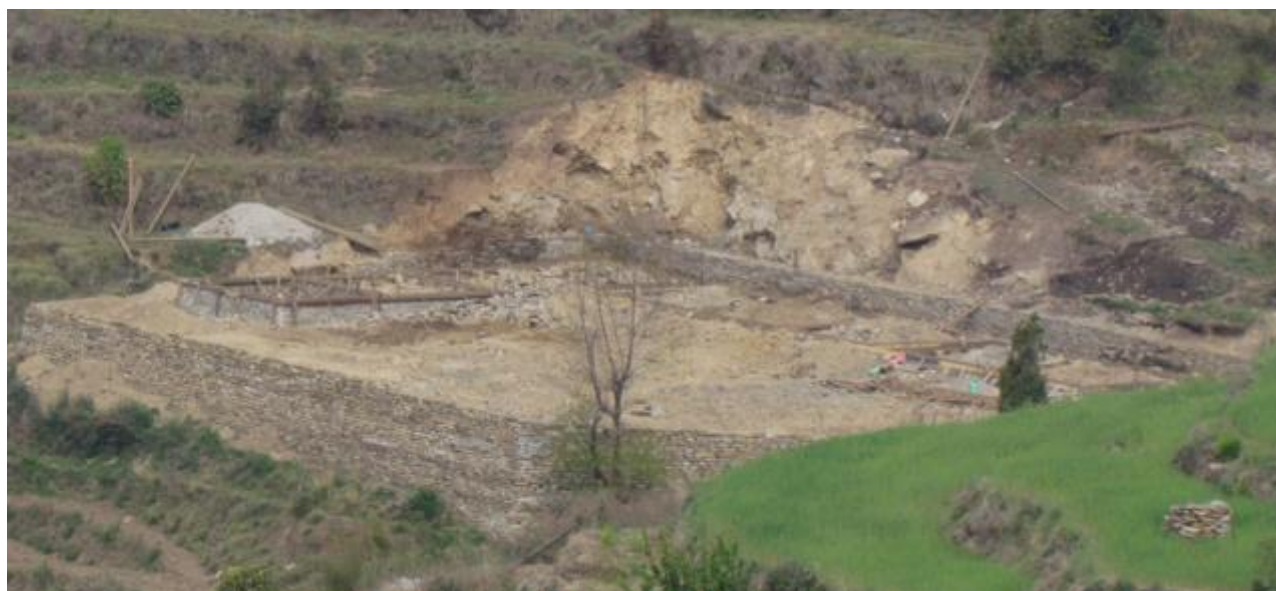
The school has received the necessary land as a donation from Mr. Chhewang who is also the contractor of the school. The legal ownership has been transferred in the name of the school. The total size of the land is

1,527 Square Meter which is enough for construction blocks, one sanitary complex and for playground.

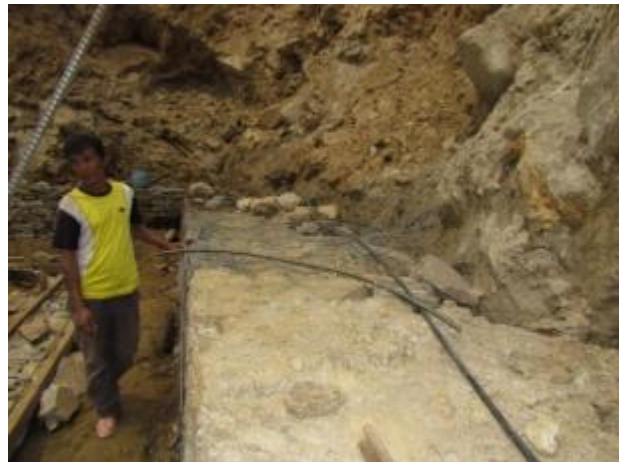
monitoring was carried out in mid-January 2015 when the preparation was still ongoing. Soon after that monitoring, the ground preparation was completed and made it ready for digging out for building the fundament. The chairman of the School Management Committee and Head Master Ngima Chhewang Sherpa informed me by telephone that the ground leveling had been completed. When I received the message, I approved and I asked the contractor to start the foundation. The digging can be seen on a

YouTube video by searching "Upper Solu".

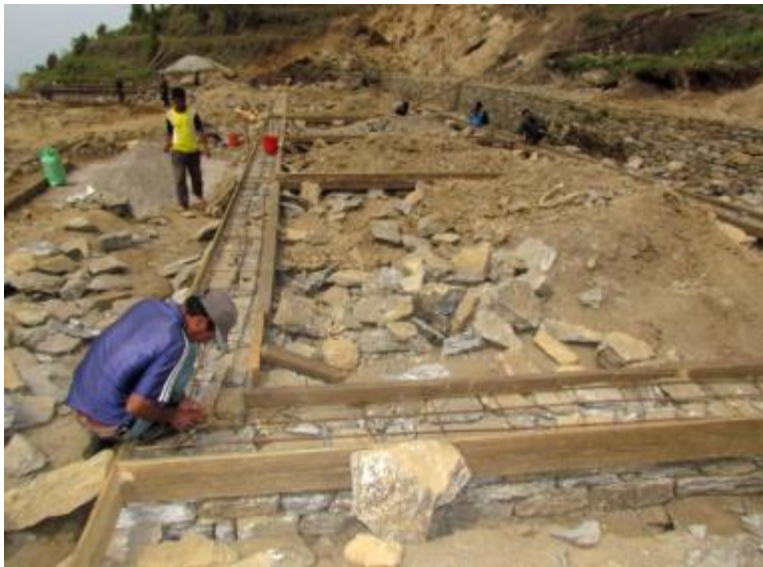
During the monitoring, it was found that they started fundament building immediately after the ground preparation by villagers was done. It was found that fundament of all three buildings are well built and quite firm.

Actually we had asked them not to put the soil from the foundation back while building the fundament or after it was built so that we could see the whole part of fundament built during the monitoring, but it was very difficult for them to stop the soil falling back during construction as the depth and base of the fundament was 1 meter width each way. As a result most part of the fundament was covered under the soil. At least it was not by the purpose.

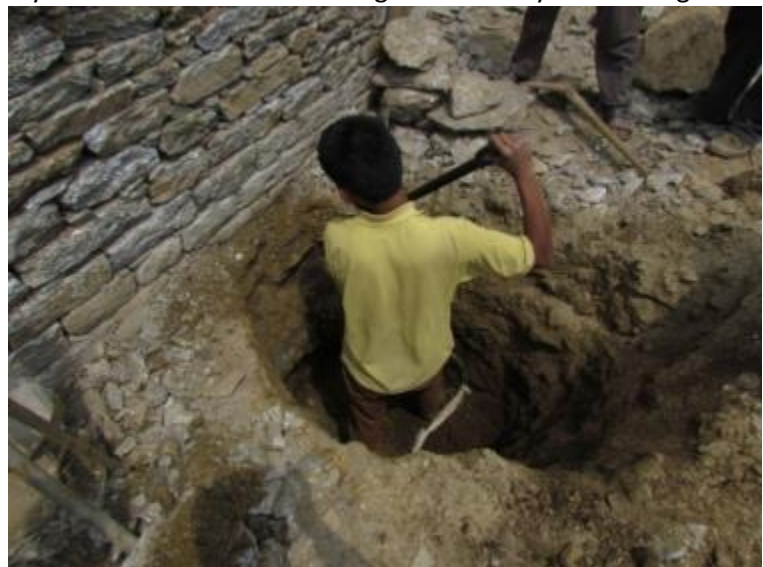
I let constructors dig out 6 different places with random sample and took measurement and photographs of the fundament. I found all measurement and quality construction to a satisfactory level.

According to the Project Description, the depth of the foundation of all three building is 1 meter. In reality I found it deeper, some part of the office wing foundation is more than 2.5 meter deep. It is because this place is made of new filling mud while leveling the ground. So, it needed to dig out all the way to the original hard surface of the earth for the stability.

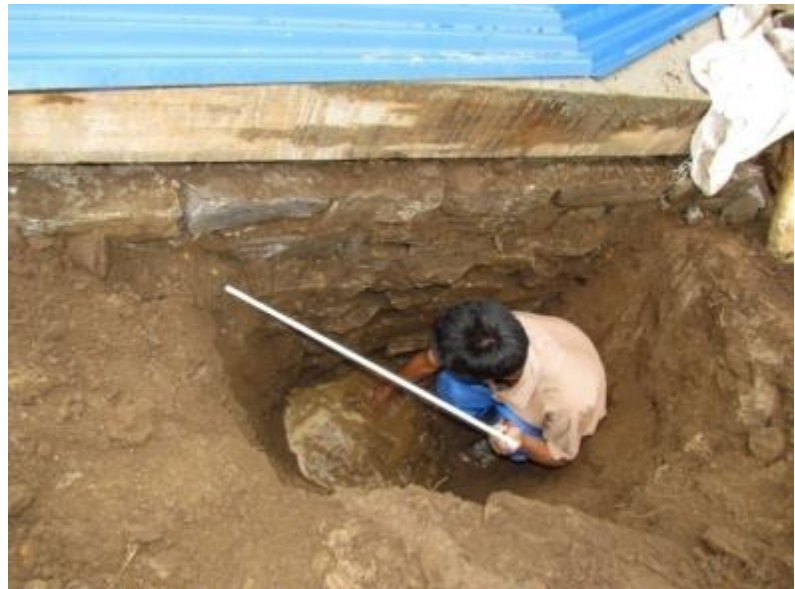
They also built very strong compound wall against the terrain with iron Gavin net at some places as you can see in the picture. The foundation of this wall is as strong as the foundation of the building.
