Chhimbu School Monitoring Report 10th September 2008

Submitted to
Himalayan Project Demark
By
Namgyal Jangbu Sherpa
Himalayan Project Nepal (HIPRON)

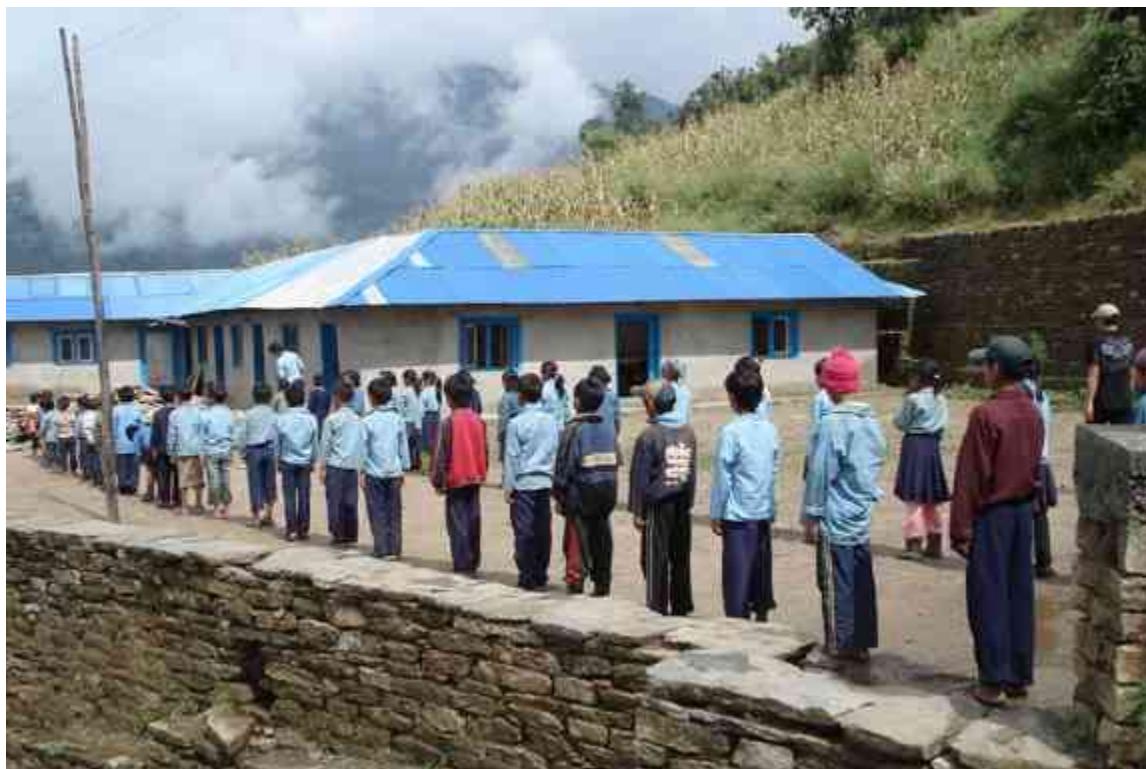
Students are queuing up for the morning exercise and morning prayer
