Final Report

about
Extension School Building & Playground
at
Chhimbu Primary School
Upper Solu, Nepal
November 2007

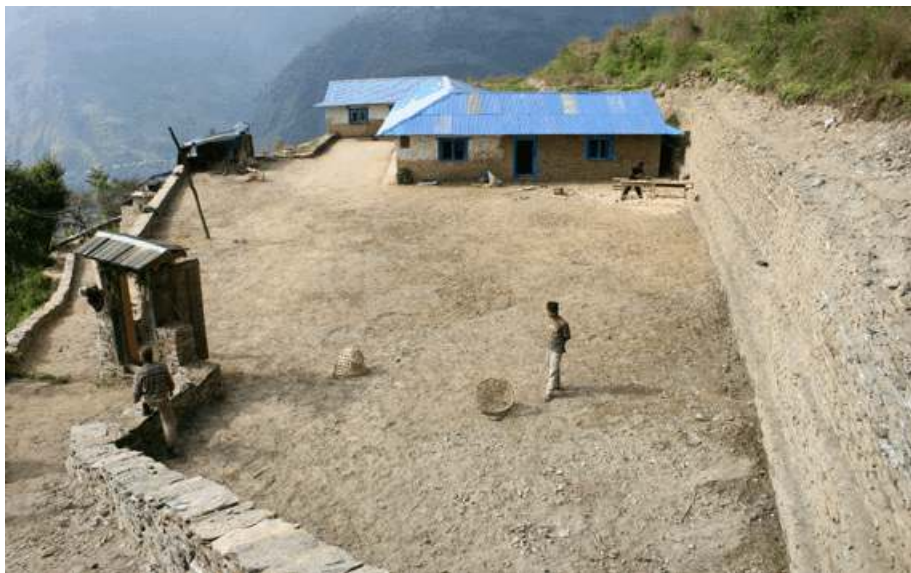
The wall between Playground and Highway is strong and well build. The wall around the Playground is quite low - too low according to my opinion. But when the surface is leveled

for more drainage it will be higher. When this work has completed, the drainage holes in the wall shall be adjusted to the surface, and then finally that upper lining of the wall, which is above the highway shall be cement topped, to secure that stones will not fall deep down on the road users.

The high wall against the backside of the Playground is huge. During monsoon it washed down and were rebuild in a stronger way. Especially in the distant corner there were problems with spring water seeping out. This part is now enforced. But anyhow the whole construction is probably the weak point of the whole project. Especially the upper lining will create problems when monsoon rain will wash down. Something has to be done to secure that the water will drain over the wall and not down into or behind the wall. But the constructors are not so worried, as all the wall already have shown their strength during monsoon, and they claim that wall build during monsoon is the strongest of all.

- a) the set up of roof ceiling in Nursery Class Room
- b) the final leveling of the playground and adjusting the drainage holes in the wall to be level with the surface. But probably this work will be ongoing for 1-2 years when the actual problem is identified.
- c) doing something about the upper part of the Back Wall of the Playground.
