# Project Description

## Remaining Work on Office & Playground

### Chhimbu Primary School

Upper Solu, Nepal

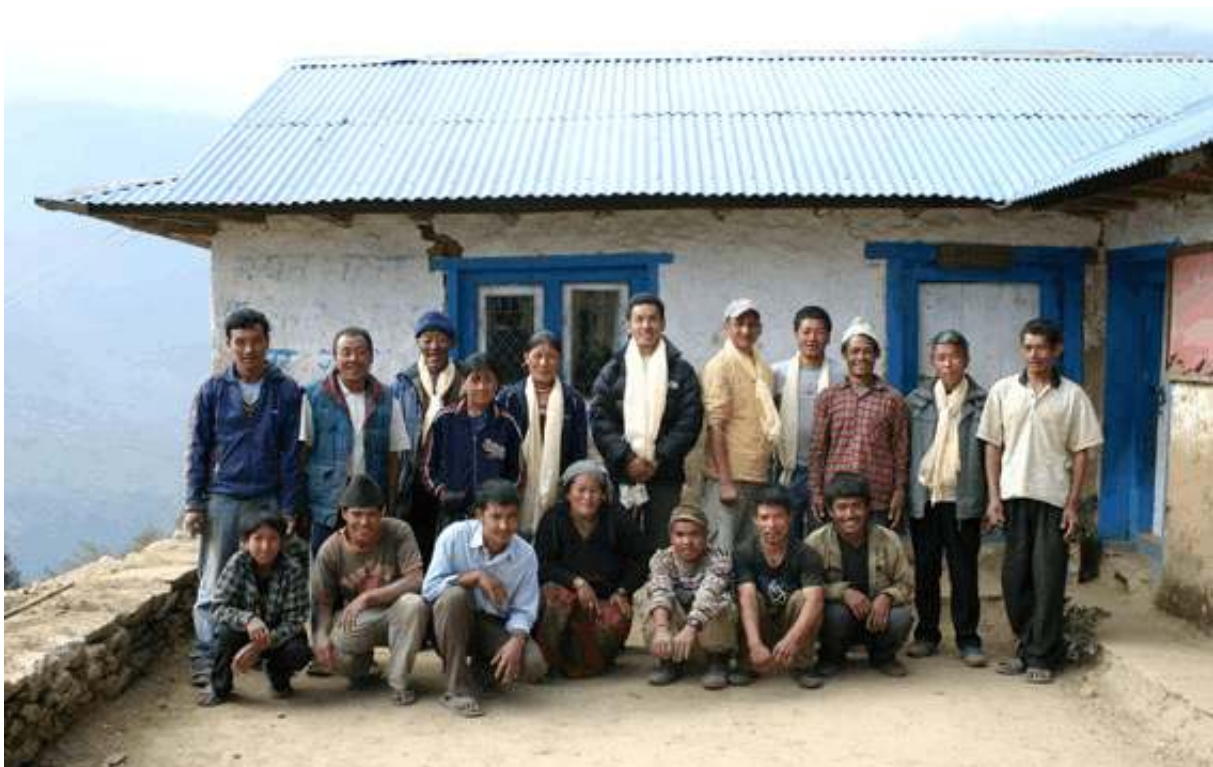
All workers, Contractors, Teachers, School Committee and Monitorer
