## Monitoring Report

26. August 2011

Gaurisankar Pre-primary School

Orale, Bakanje-2, Solukhumbu

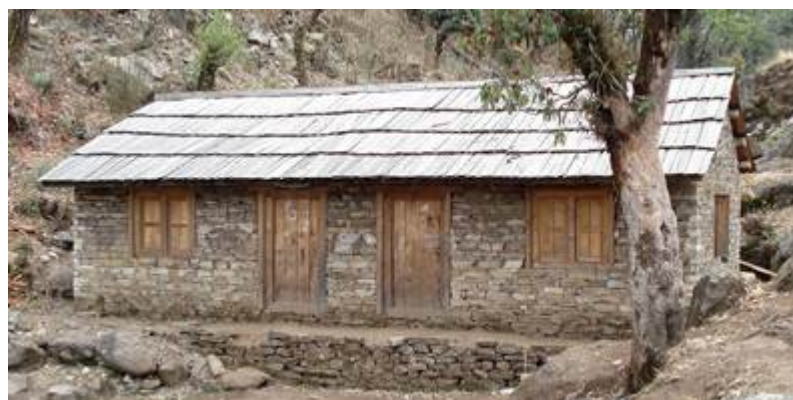
The physical condition of the school before reconstruction

Before the reconstruction, the physical condition of the school was very much incomplete to be known it as a school. There was exterior structure with almost

rotten plank roof and some old furniture and stone flour inside. But there was no ceiling on wall and under roof. Inside the rooms was very cold in the winter that no children wanted to stay inside. There was lacking cupboard to protect the stationeries and other valuable document of the school. Besides, the school was lack of drinking water and toilet. Kids used to go down to the river for both propose.

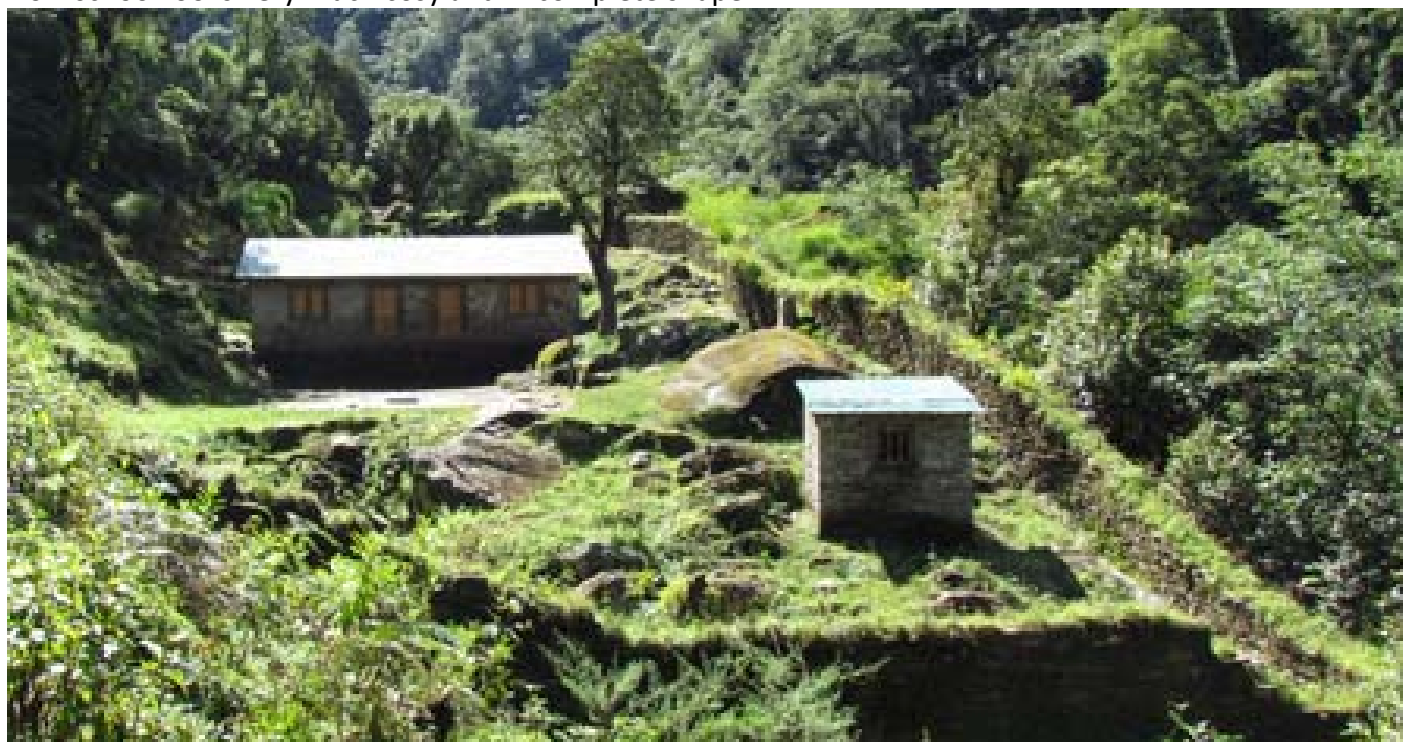
After reconstruction, the appearance of the school has changed and it looks very attractive. All the constructions except the rack are completed more or less meeting the standard demanded by HP-DK in the project description, the Project Description 27, January 2010. The compound wall has been well built. Its length has necessarily been increased by 2 meters while the depth of the foundation is lessened by 0.2meter. The height of the wall is 0.16 meter higher than that it was mentioned in the project description. The quality of construction and used stone was found to be very satisfactory. They have planted turfs on the top of wall all the way which has tightened the wall and stopped falling the stone down. The construction of roof, room ceiling, furniture, toilet and water supply are also successfully completed. Now school looks very much cosy and in complete shape.

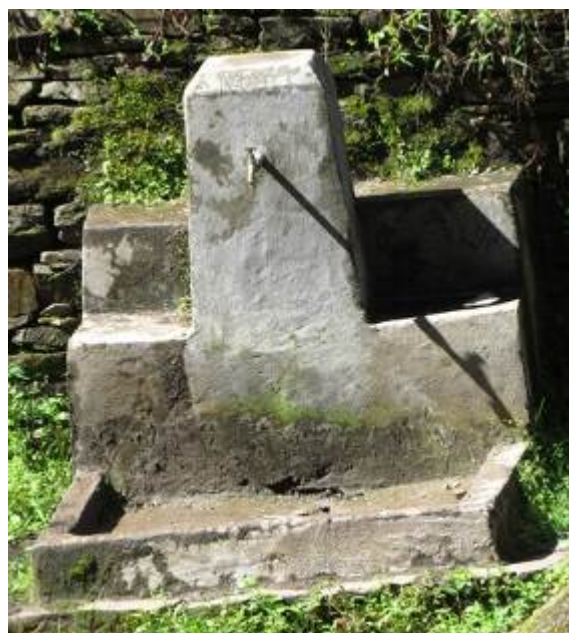
To be honest, the water tap is not well constructed. Quality is not good and skill of the worker has definitely not reflected on the water post. It doesn't look nice and the water outlet system is also not well connected. While opening the tap, the water splashes out of the water post and causing damp around the water post. I did ask Construction Chairman Ngima Chhiring in last February to reconstruct it but it was not done as he was sick and was brought to Kathmandu for treatment. Actually we had asked the construction committee to make the water post in traditional design but that was not observed. It is ok. Now there is water supply and children can get the water whenever they need the water, and that is the great thing. However, the water post needs some repair to make it nicer. It only needs some cement and 1 skilled man. The water should be guided in proper way not to have splash out on the kids dress when they are trying to get water.

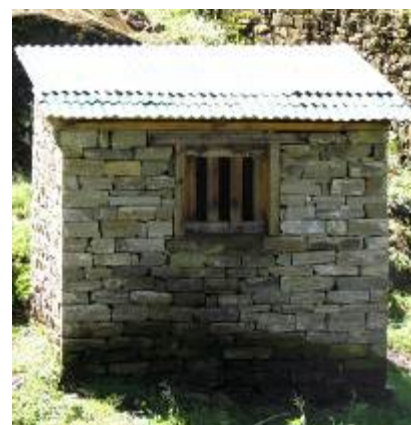
Now there is facility of the toilet and no kids have to run into the bush for toilet. Although it was mentioned simple toilet in the project description, the standard of the construction is much higher. The toilet has got cemented floor and partially plastered the inside wall with cement, and there is water supply. This toilet is located about 20 meters away from the school yard inside the compound wall.
