Monitoring Report of Solung School, 13 September, 2008

Himalayan Project Denmark

Himalayan Project Nepal(Hipron)

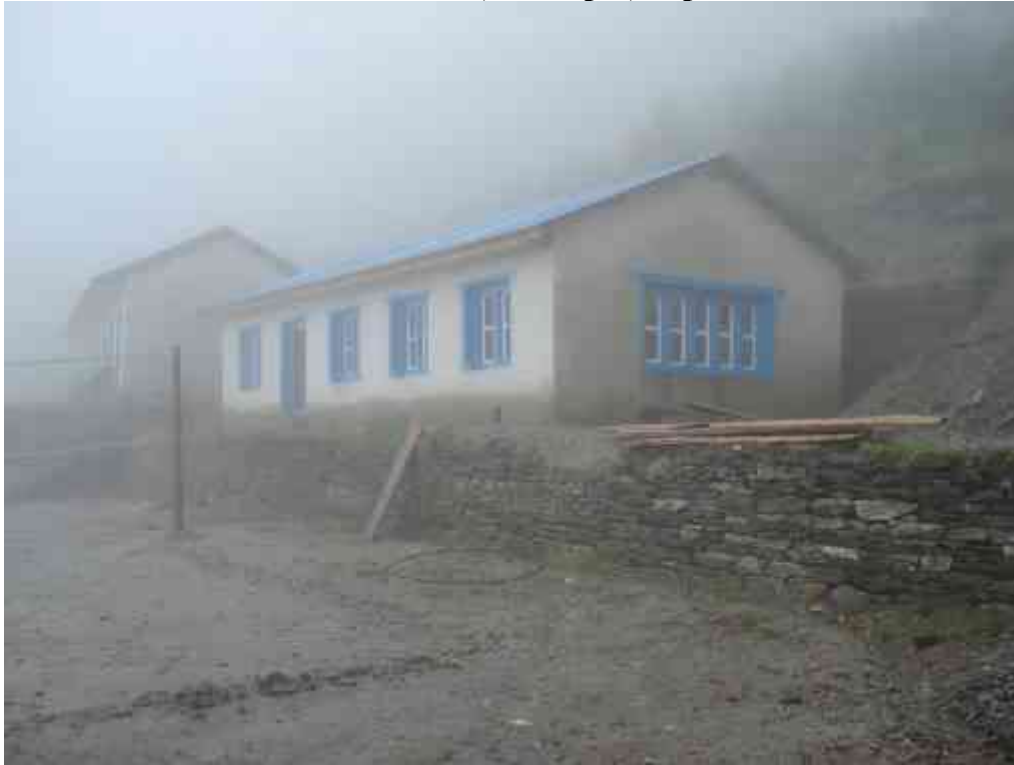
Solung school construction site has been monitored on 26 August, 2008 and found this site has successfully completed. Building looks very beautiful and inside is just more beautiful. The building has 3 rooms: office room, science lab room and store room.

All rooms are very nice with full of light.

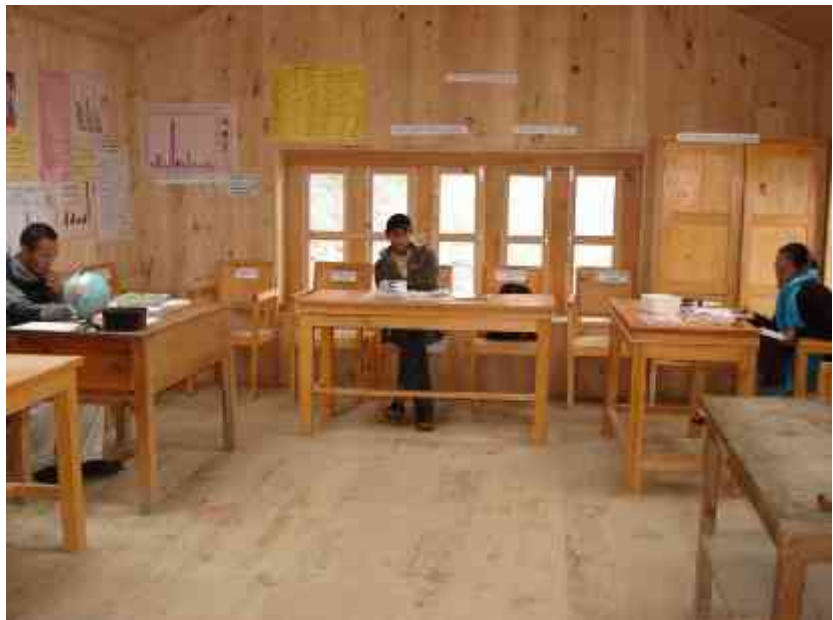
Ceiling work inside the constructed building

Inside decoration of the office with ceiling was done efficiently. No place is left where one can complain. Everything is just fine. It looks as if the most skillful carpenter was involved in the construction site. The quality of the work is really praiseworthy. The planks used for ceiling have been burnished and room look very clean and shining by the full of light.

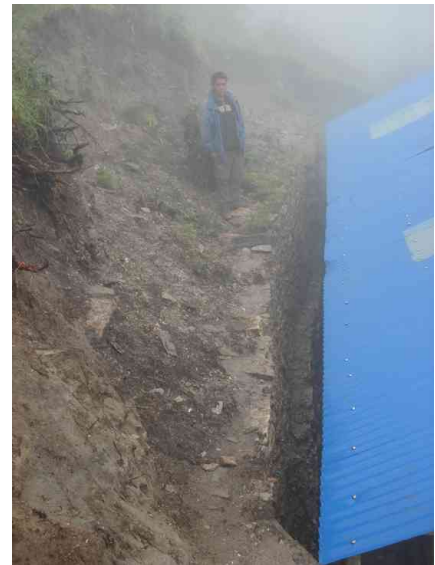
Wall behind the office building

The construction site completed a month ago. But the small mound of mud with stone was rolled down which damaged wall behind the building and 3 pieces of tin plats. The place behind and above the newly constructed building was quite damp and not compact and it caused the landslide. Damaged wall was immediately repaired in such a way that no more landslides will occur at this place. Tins of the roof are yet to be replaced, fortunately there are 3 tin plats left and that will replace the damaged are. That will be done very soon.

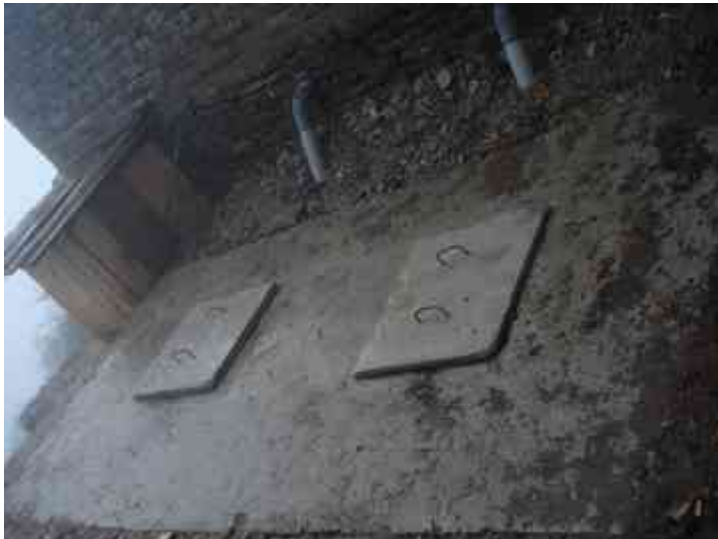
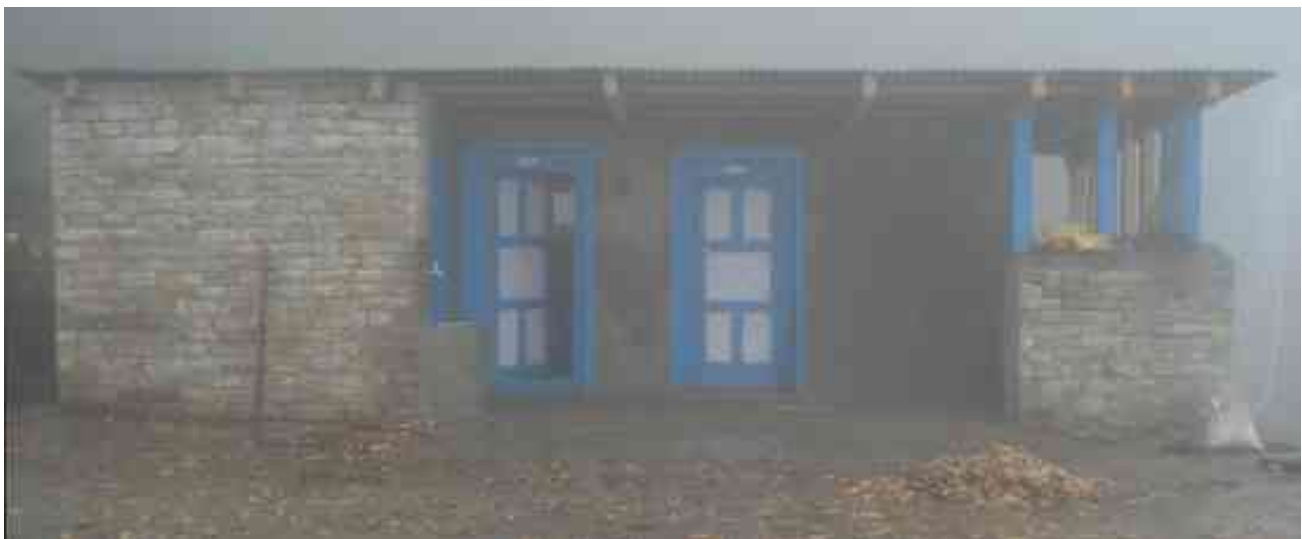
Toilet Construction

Most of the work of toilet construction has completed. Structure of the toilet and septic tank are constructed exactly as the drawing and project description. But pipe are fitted to the septic tank separately: each toilet room is connected to each septic tank - not according to the drawing. Structure of the urinal drain has been distorted. Constructors were confused with drawing. I have directed them that they should follow the project description. I explain them a project

Cement plastering inside toilet room, bathroom and urinal drain are not smooth enough. It needs to be smeared with pure cement making more smooth to give good finishing. I also asked them to complete all the cement work with the toilet make standard as high as it is mentioned in the project description.

description once again. I requested them not to construct the toilet as they like but just follow the project description seriously and drawing of the toilet.

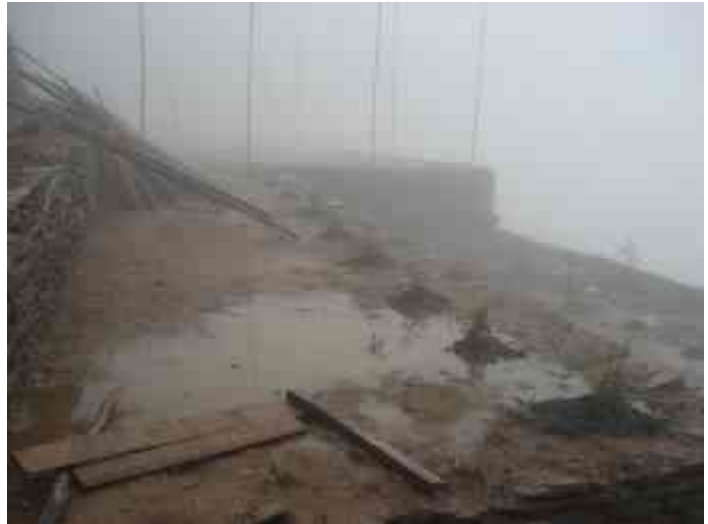
Playground and net with iron pole

Construction of playground and garden has completed. Iron pole have also been erected surrounding the playground and fixed with nylon net. But net doest look long lasting. New garden has got some rhododendron and pine tree planted. The area of the playground is in length 33.5 meter and in width 14meter. Area of the garden is in length15.5 meter and in width 6.2 meter.

Each pole are arected in the distance of 3.2meter.

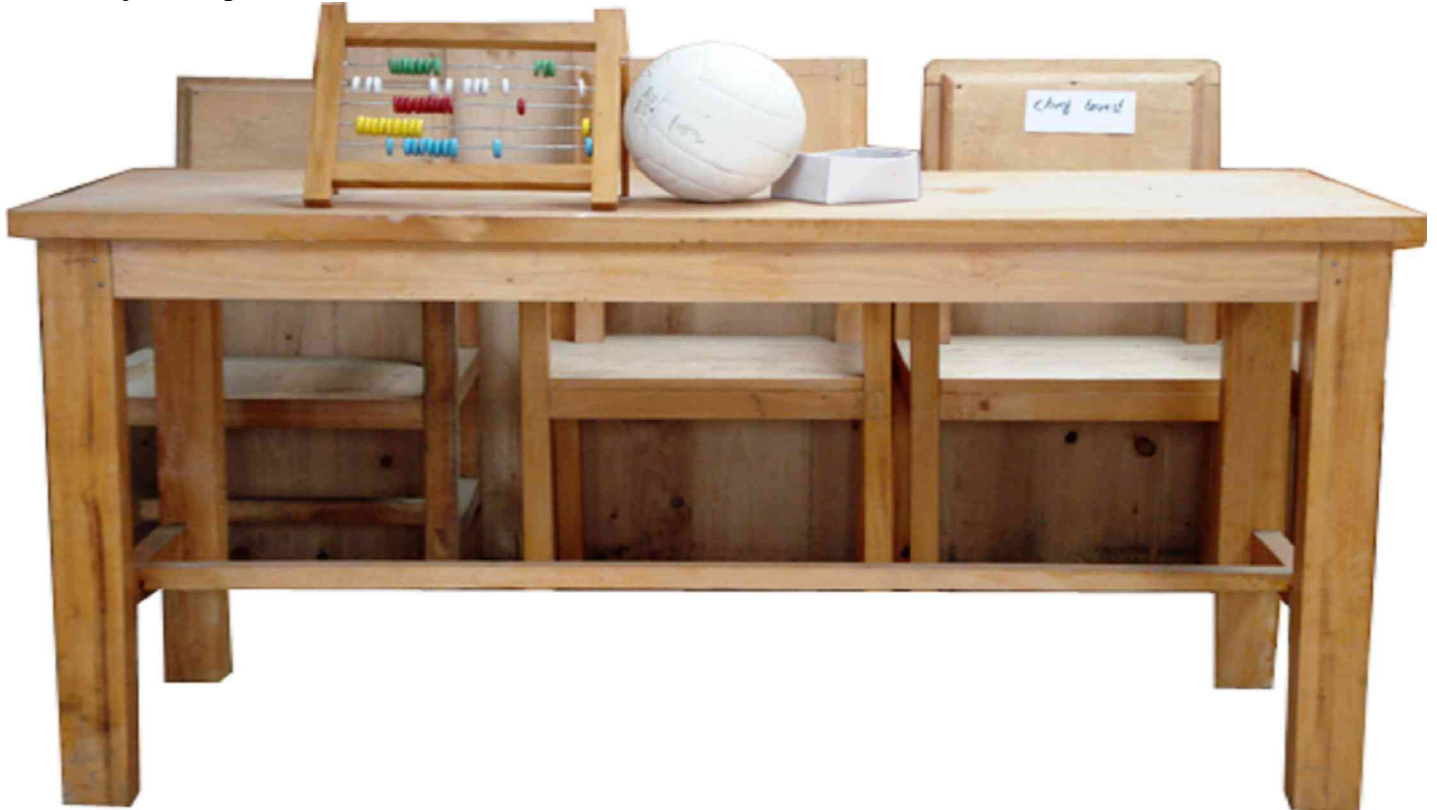
Furniture

2o new chairs, 2 office table and 1 science table and 1 bench have nicely been made. They are made of a good quality of the wood with good finishing. They look very nice and beautiful. Measurement of science table is: in length 152cm, in breadth 67cm and in height 80cm.

Office table is: in length 151cm in breadth 60cm and in height 83cm.

Bench is just simple and for the children.
